Surface Degradation Analysis of Vacuum Composite Epoxy Resin Insulation Material Using Coastal Sand and Filler Containing Much Calcium

Abstract. One of the insulating polymer in high voltage air insulation materials is epoxy resin because it has several advantages. However, has a degradation of the surface due to environmental pollution. Material that was used in this research was epoxy resin polymer isolation using of comparison values, material DGEBA : MPDA were 1:1, with the increase filler. Vacuum method to left out void. Research was done in laboratory according to standard IEC 587: 1984. High voltage electrodes were connected to high voltage AC generator 3.5 KV. The ground electrode was connected to oscilloscope for measuring the leakage current. The effect of variation were analyzed. From the results of the research, the composite are categorized as hydrophobic and partially wetted. The increase concentration of filler caused the increase in contact angle, slow down the aging on the surface of insulating material. Concentration value of filler that had the optimal performance was 40%.

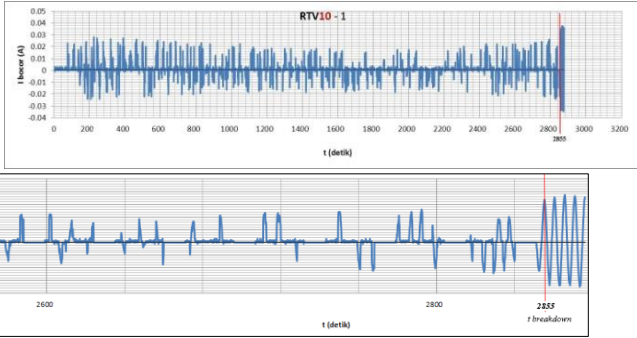
Fig 4. Result of composite leaky current test of resin epoksi RTV10 sampel 1

Result of this leakage current test shown by picture voltage waving at oscilloscope. Value waving this voltage represent the value of oscilloscope input from voltage divider network.

Fig 5. Result of magnification 10x range moment of before breakdown

Pursuant to fig 5, inferential that happened the payload discharge (*flashover*) at second 77. This payload deprival marked with the existence of leakage change magnitude current on the spur of the moment. This payload deprival happened till many times, then happened the insulation failure marked with the leaky wave sinusoidal current at second 2855. this sinusoidal wave indicate that have been happened the intact conduction band from electrode high voltage to ground electrode.

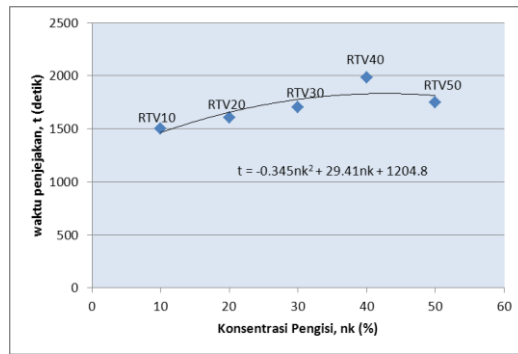
Fig 6. Graph of relation tracking time with the composite filler concentration.

From test result, earn also obtained time tracking of mean each concentration resin epoxy filler. Relation between tracking time and value the composite concentration visible epoxy resin shown at fig 6.

From fig 6, visible that increase value the composite filler concentration epoxy resin tend to cause the increase of tracking time. This matter indicate that the composite filler concentration excelsior resin epoxy hence process the happening of band of conduction and carbon band at surface of insulation materials will tend to tardy progressively, so that can slow down the happening of degradation surface.
